MAGISTRATES COURT of TASMANIA
CORONIAL DIVISION

**IN THE MATTER OF AN INQUEST
TOUCHING THE DEATH OF
LARRY PAUL KNIGHT**

**FINDINGS, RECOMMENDATIONS AND COMMENTS of Coroner Rod
Chandler following an inquest held in Launceston on 22 July to 25
September and 11 November 2008.**

26 February 2009

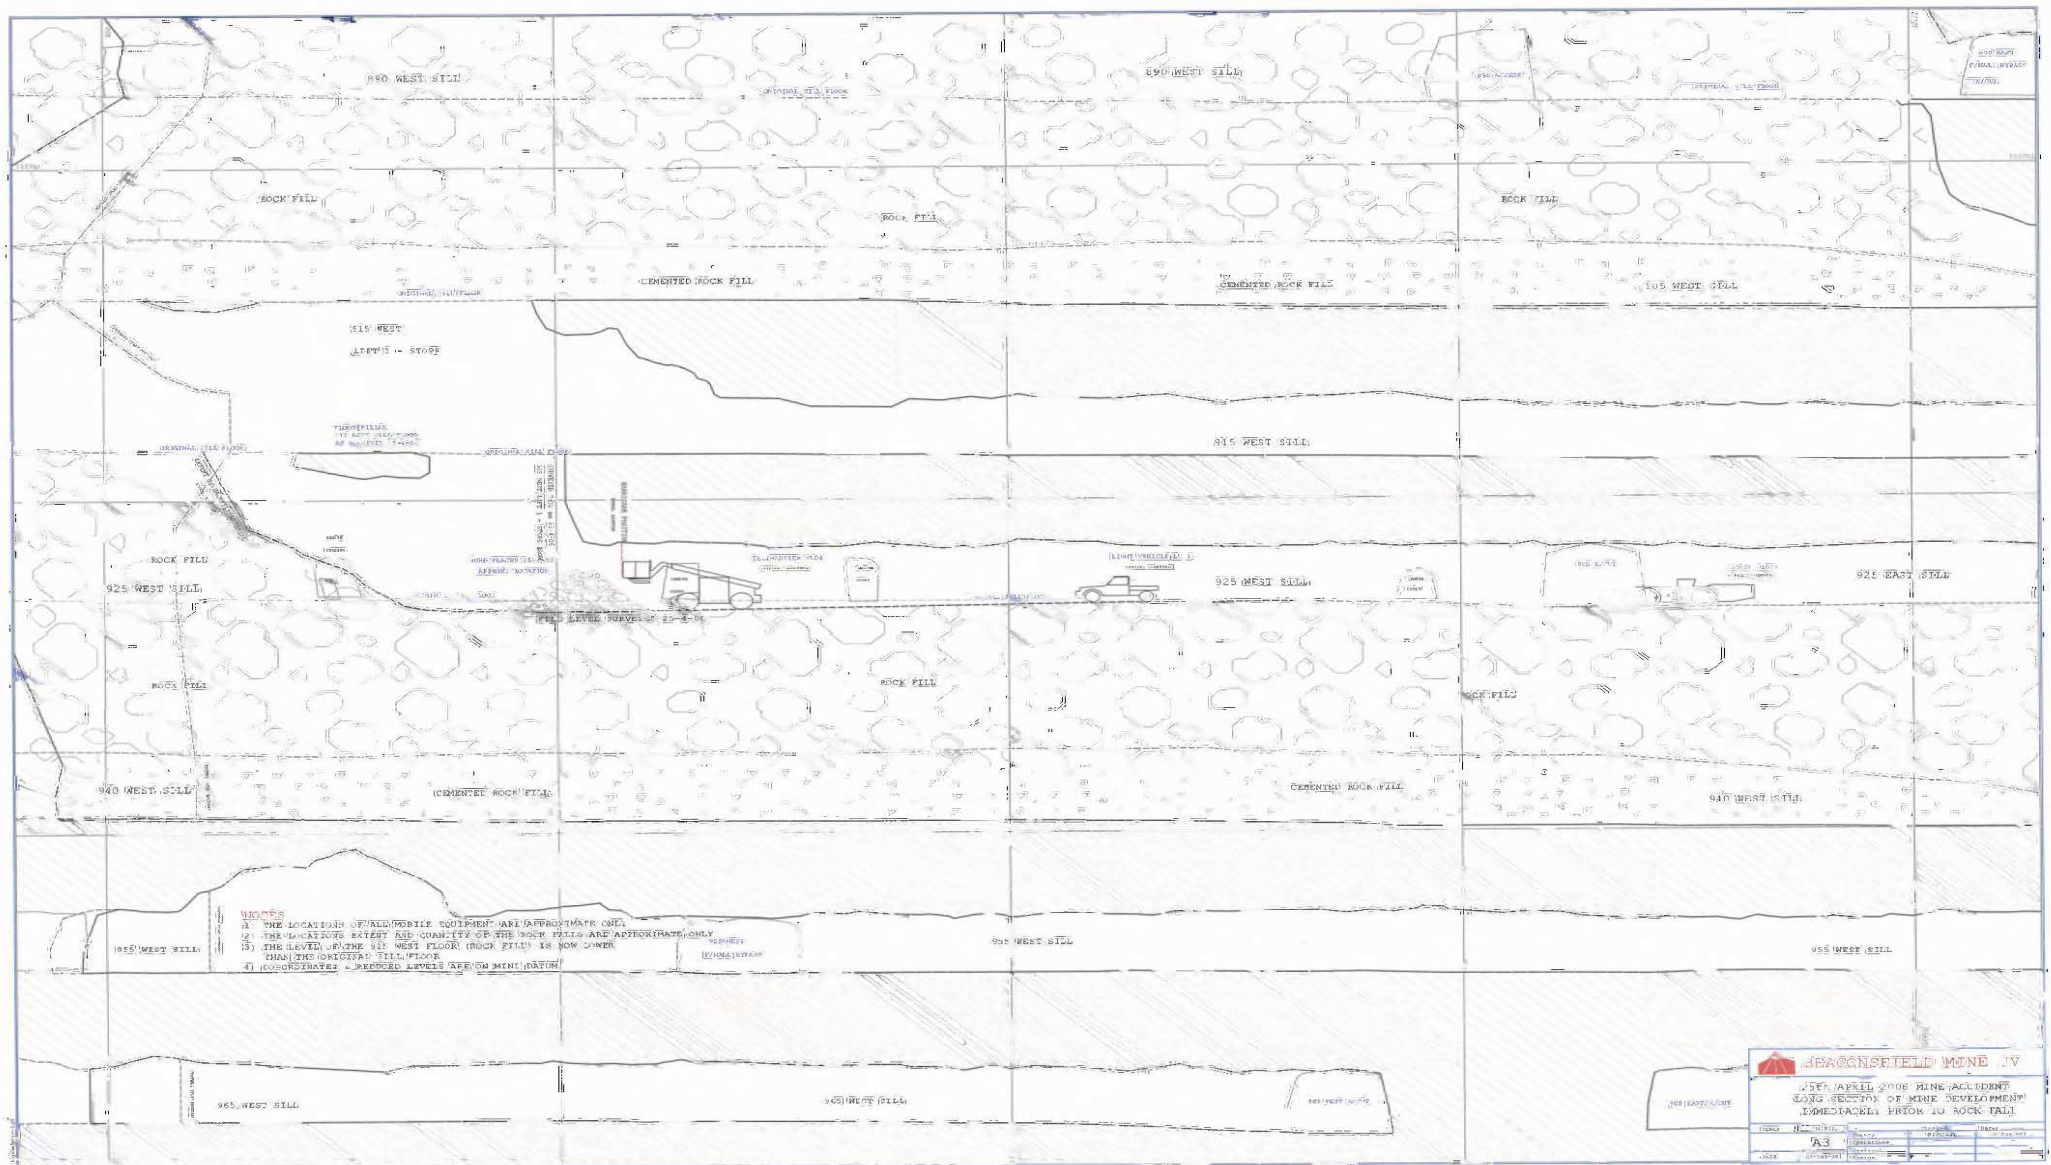
- 2.1.4. It is clear upon the evidence that at 9.23pm a local magnitude 2.3 seismic event occurred at BGM and that it caused three falls of ground within the 925m drive and another in the 915m drive. Of those in the 925m drive, the largest comprising about 800 tonnes engulfed the telehandler and caused the entrapment of Mr Russell and Mr Webb within the metal cage. The second of about 120 tonnes was smaller and occurred about 5 metres to the rear of the telehandler and in the area of a remote cuddy. The third and much smaller fall of ground occurred in the area of the access to the drive.

Fig. 9 is a long section depicting the 940 stoping block after the Anzac Day event
