Mining Warden
Yallourn Mine Batter Failure Inquiry

Ordered to be printed

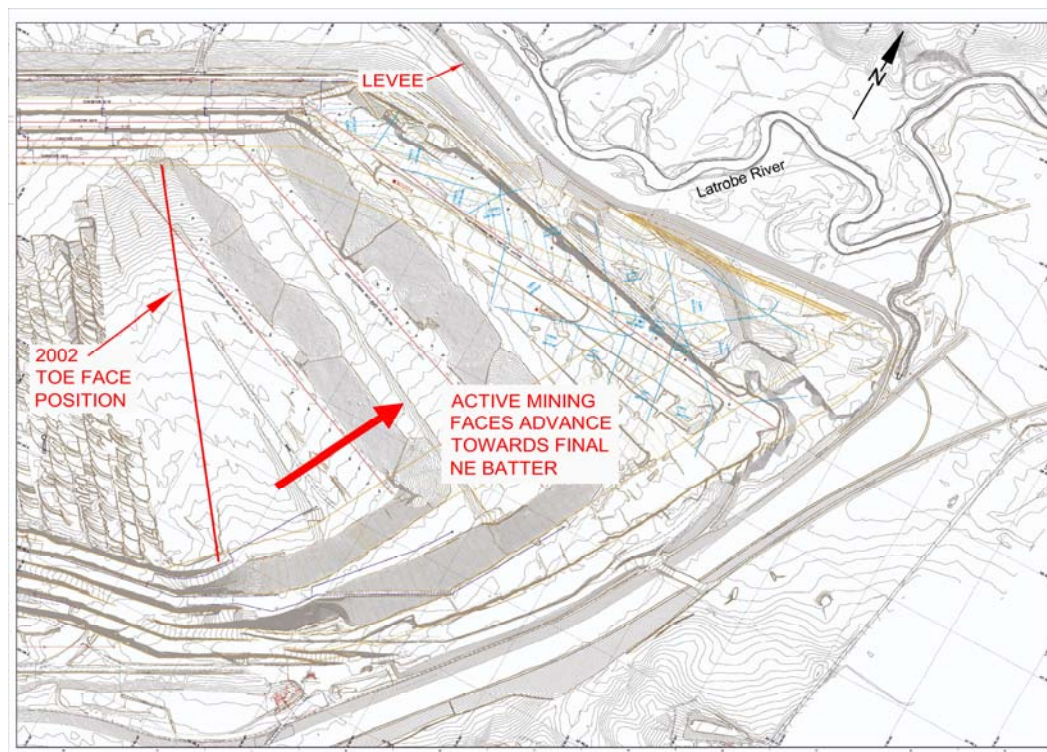
Figure 2: Yallourn East Field March 2005

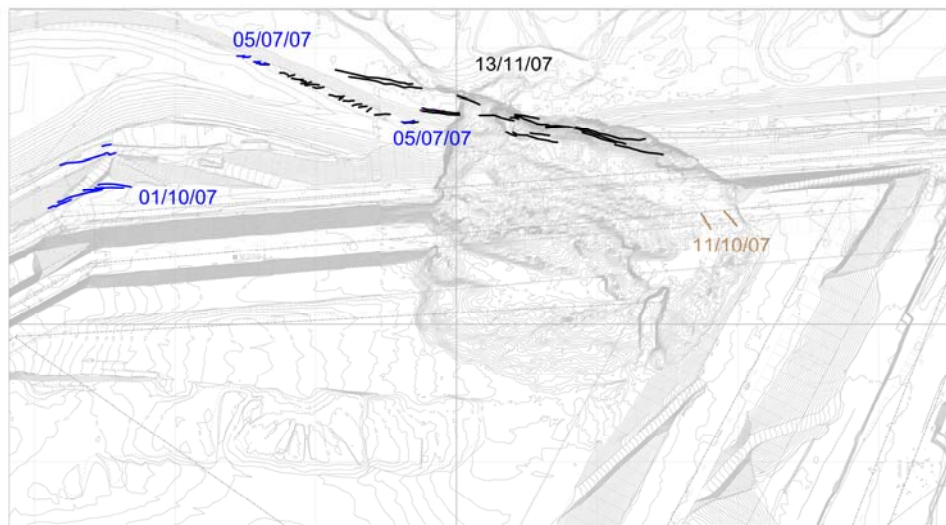
Figure 6: Cracks mapped prior to failure; colour coded with dates shown

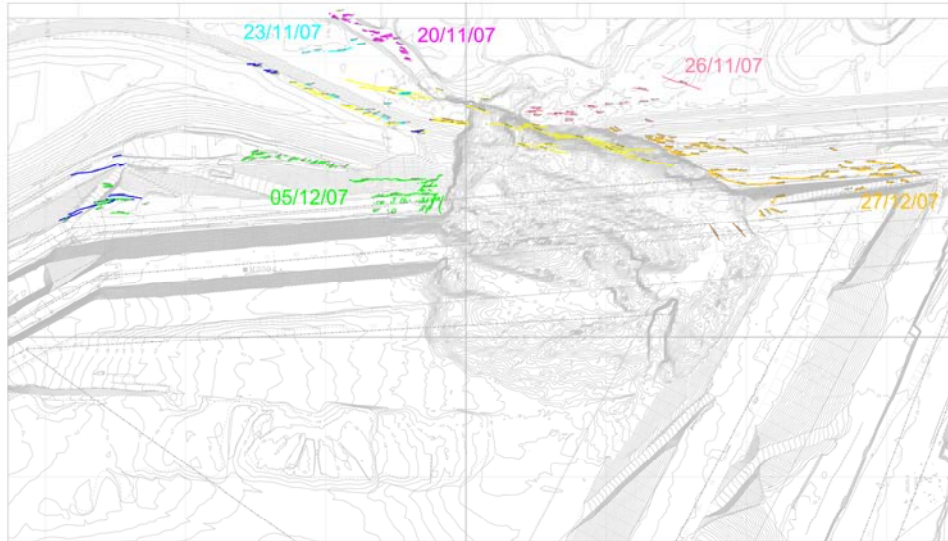
Figure 7: Cracks mapped after the failure; colour coded with dates shown

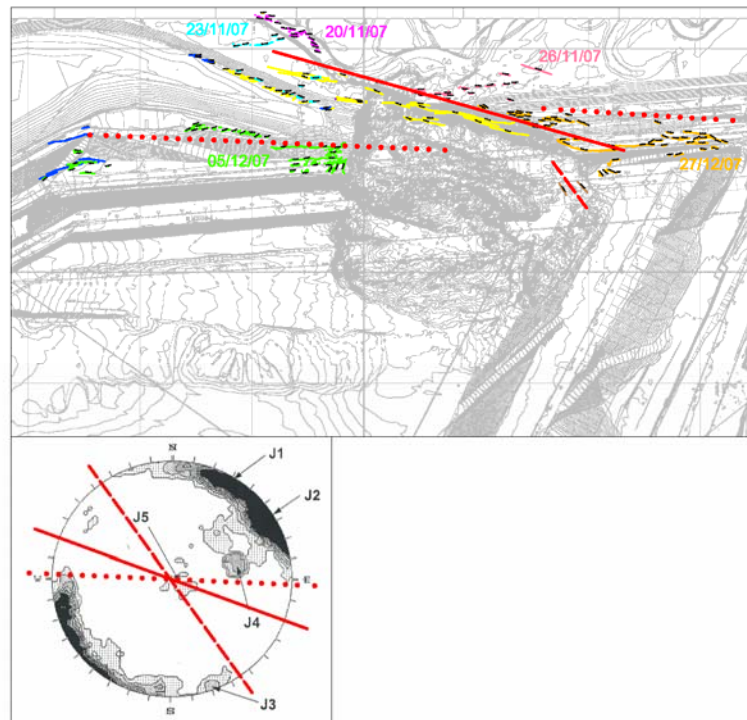
Figure 8: Comparison between cracks and joint data (1997)

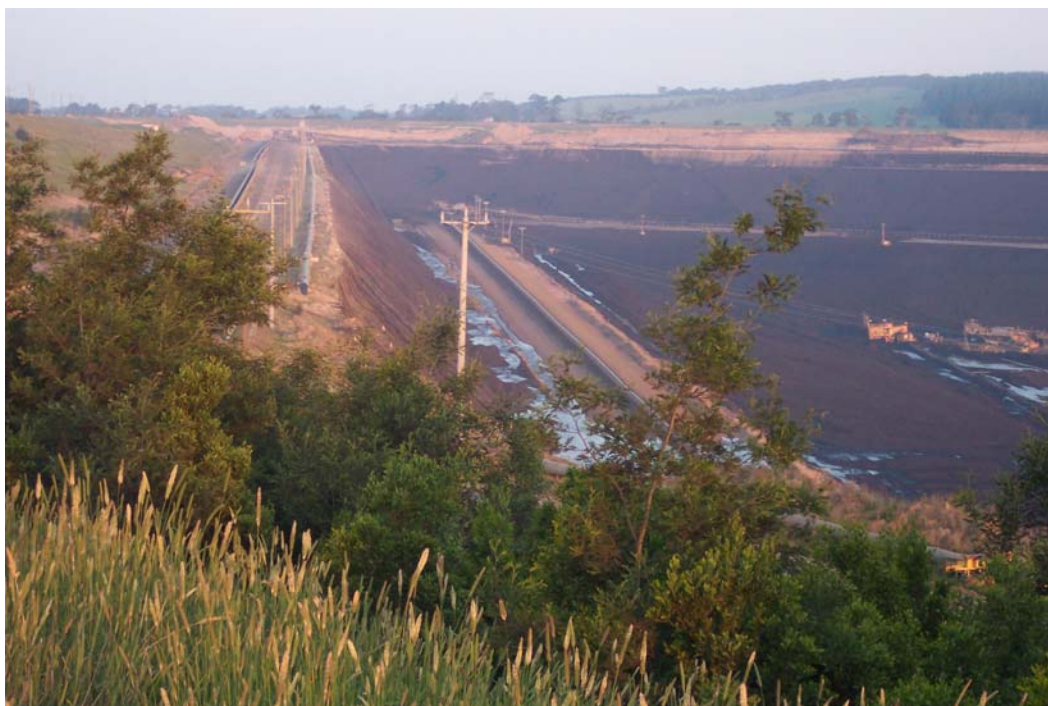
Figure 9: General view along, NE Batter, note the bends in the pipeline and the line of power poles

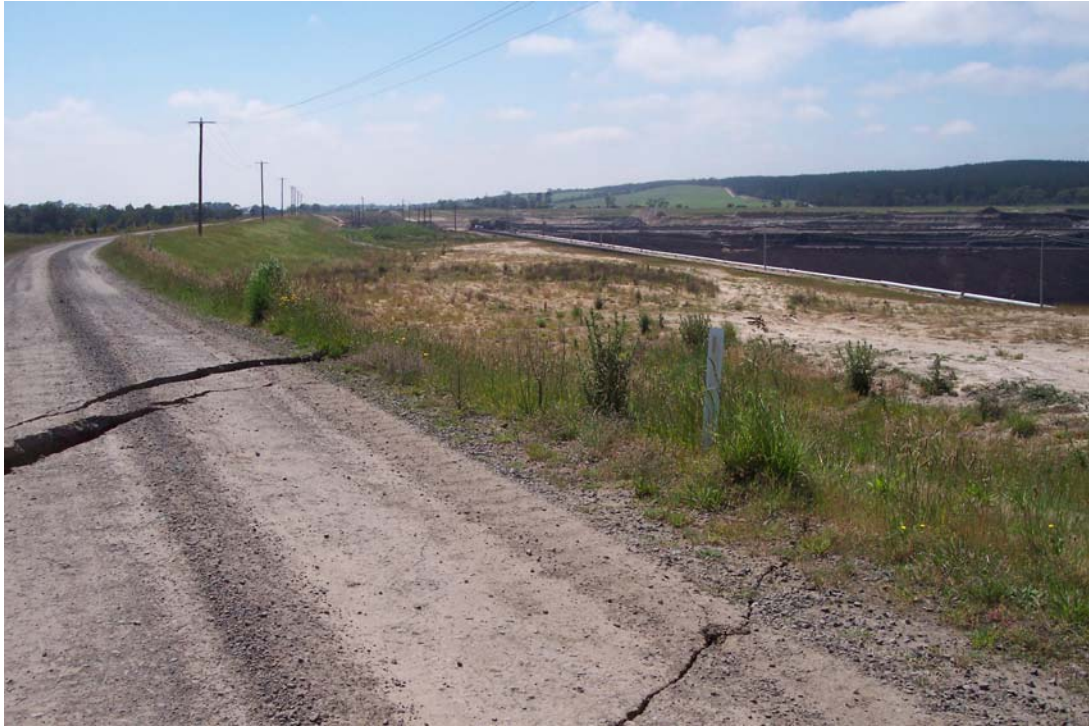
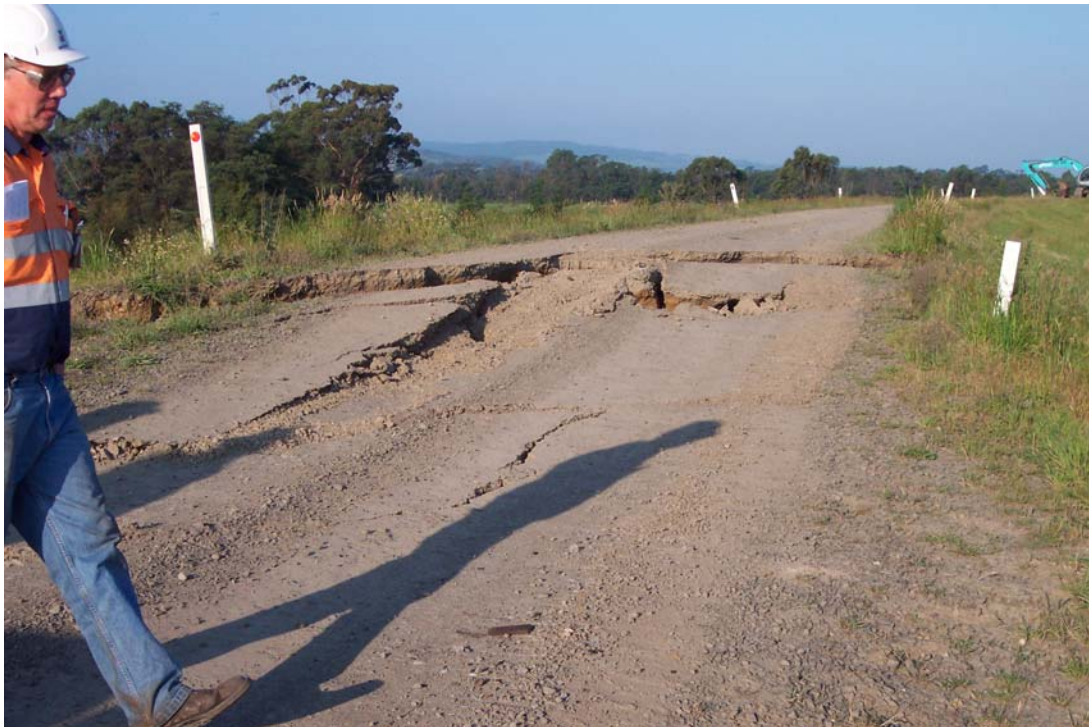
Figure 10: Cracks and subsidence across the Latrobe River Levee

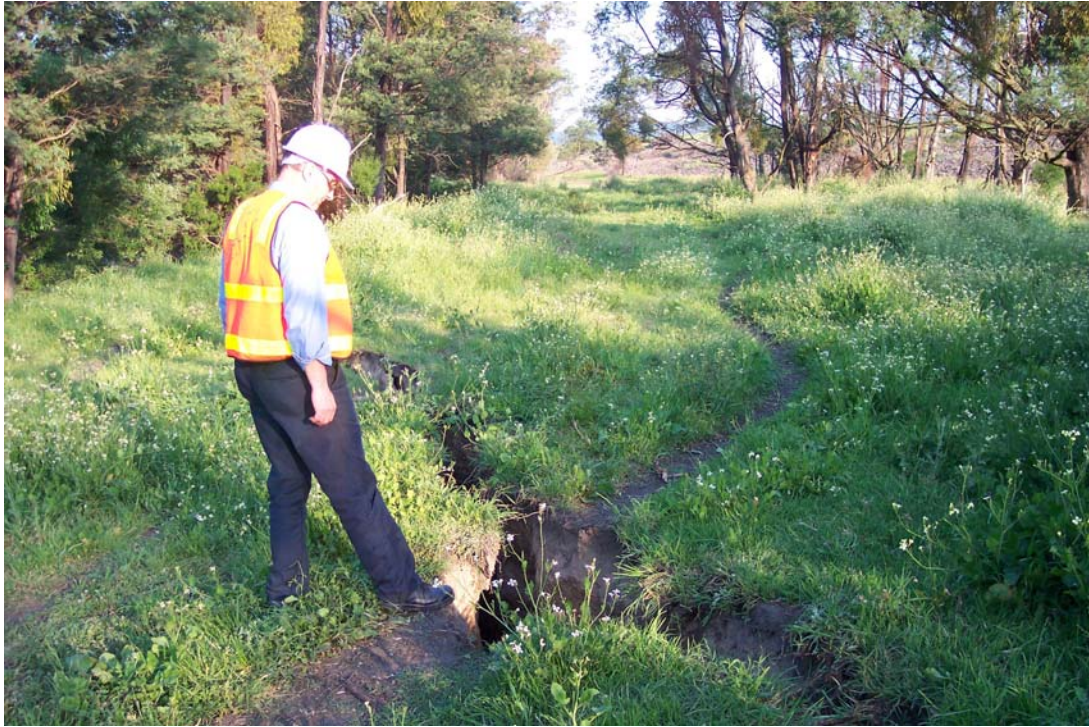
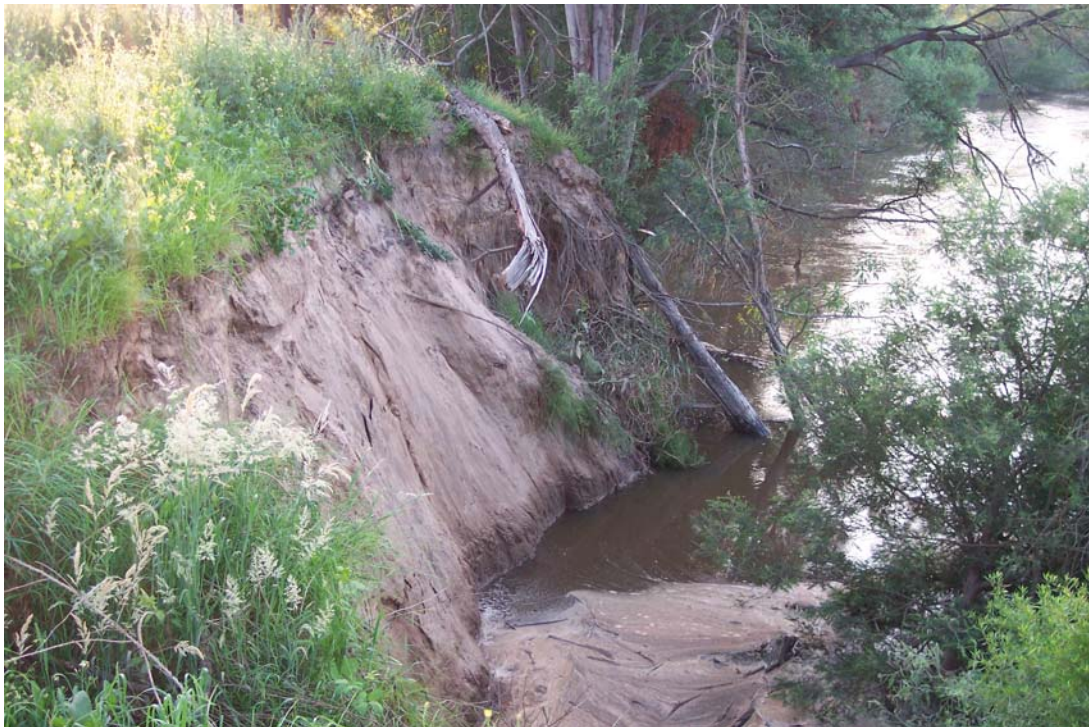
Figure 12: Crack in Latrobe River Floodplain and Latrobe River

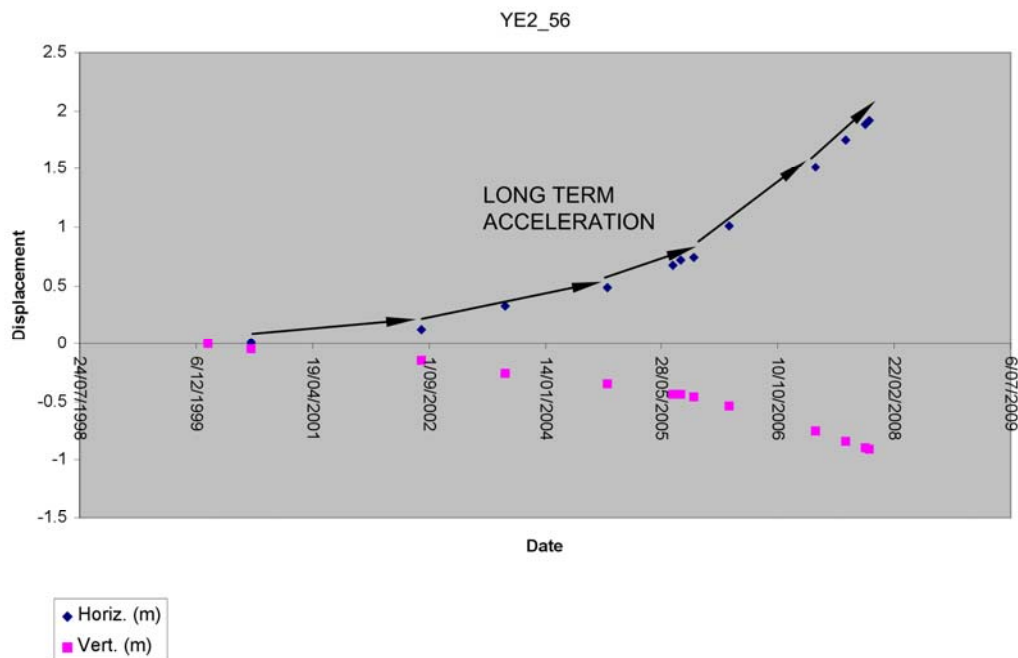
Figure 15: Long term movement for Batter pin YE2_56

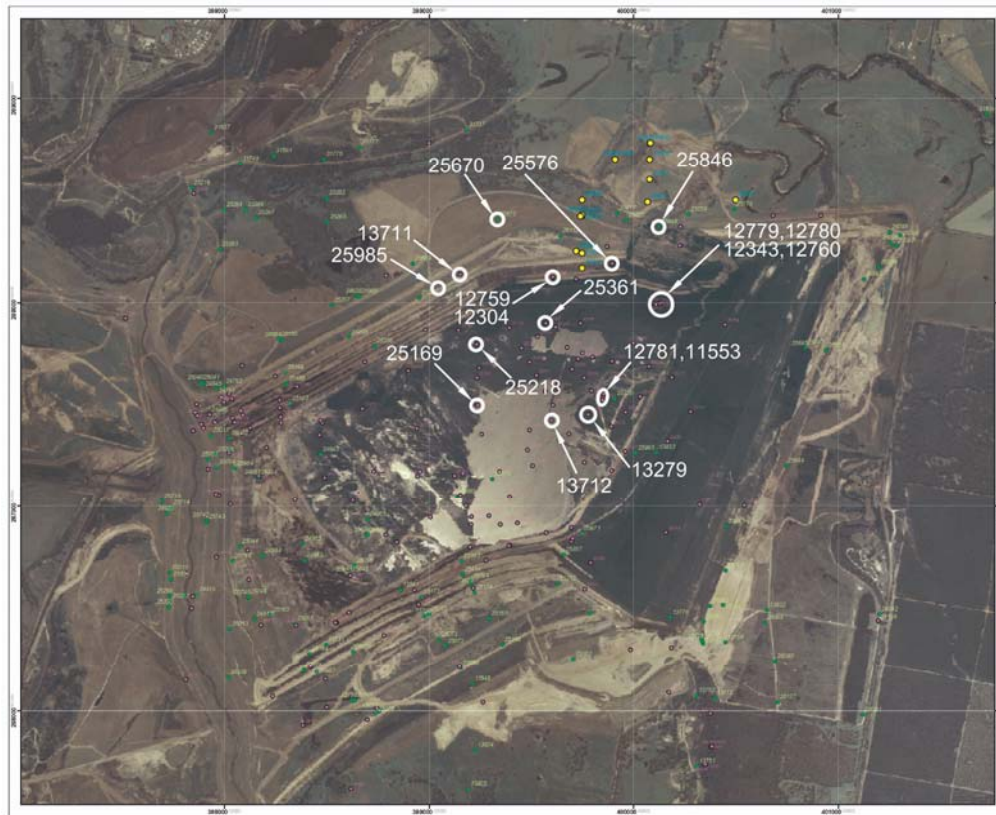
Figure 17: Piezometer locations around the NE Batter

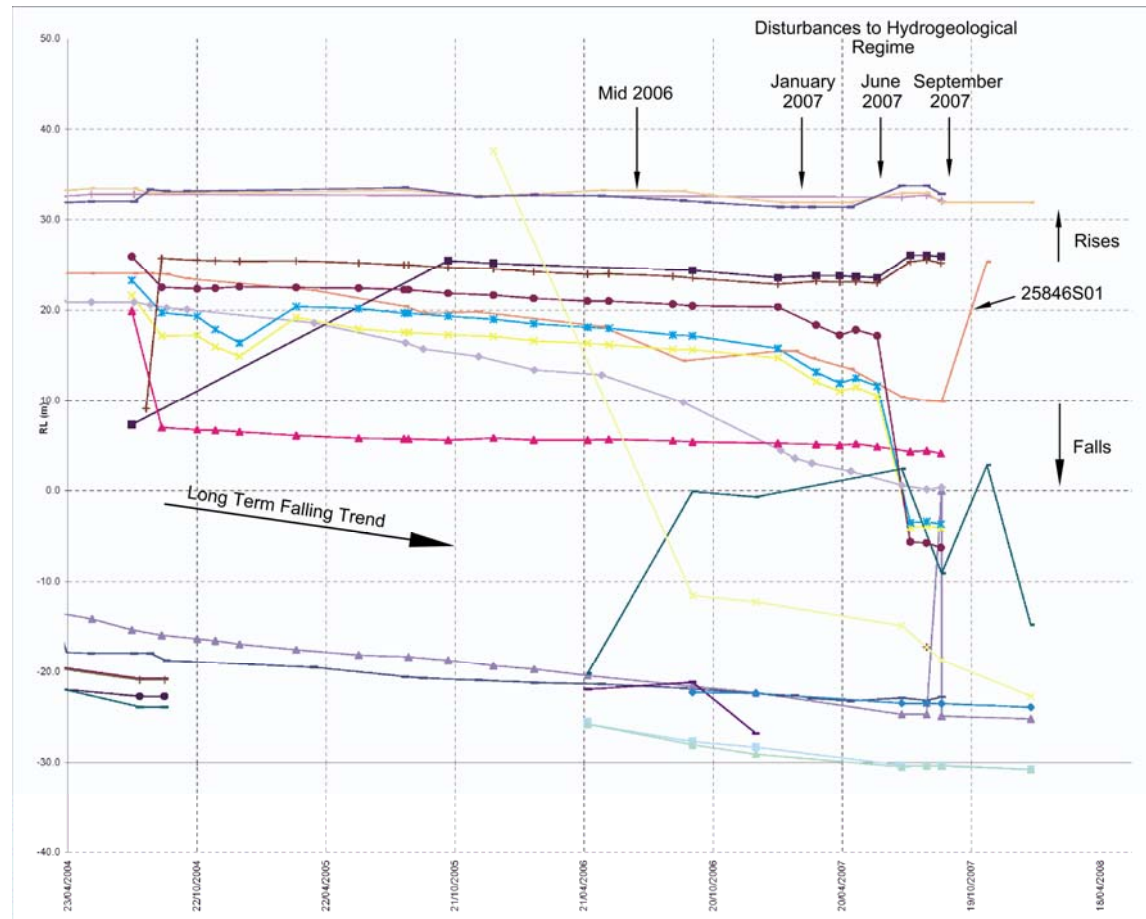
Figure 19: NE Batter piezometers 2004 to 2008

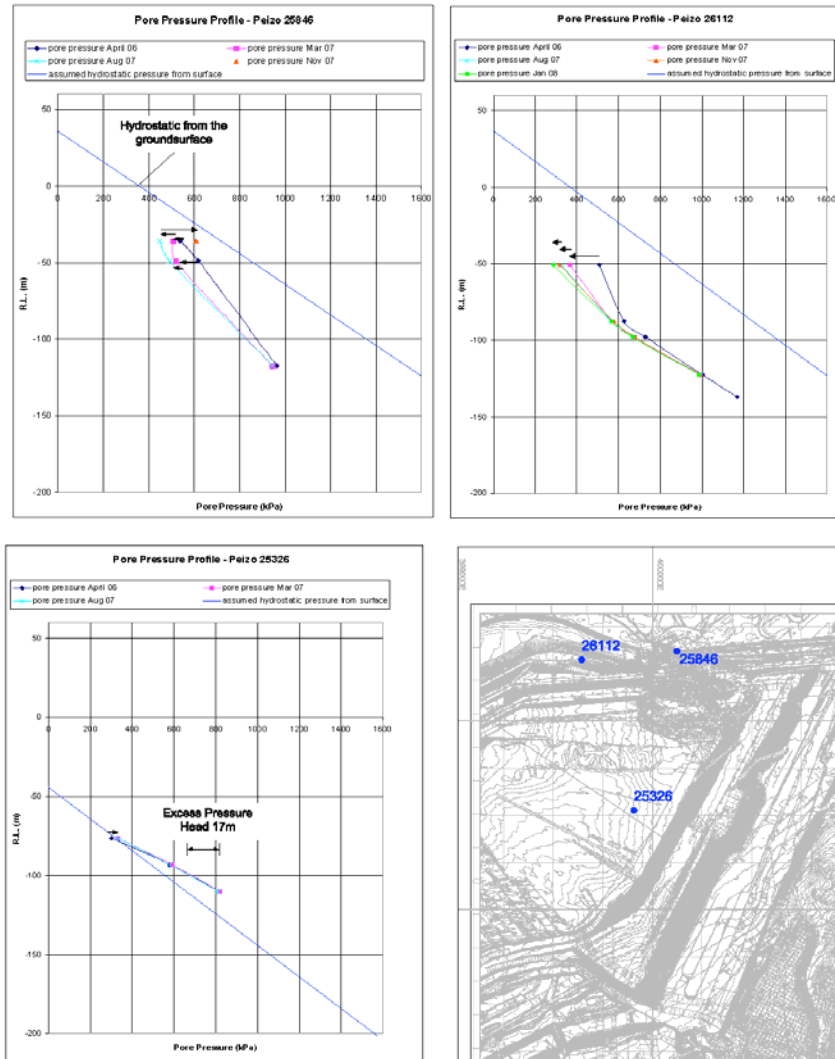
Figure 20: Piezometric pressures with depth showing changes over time

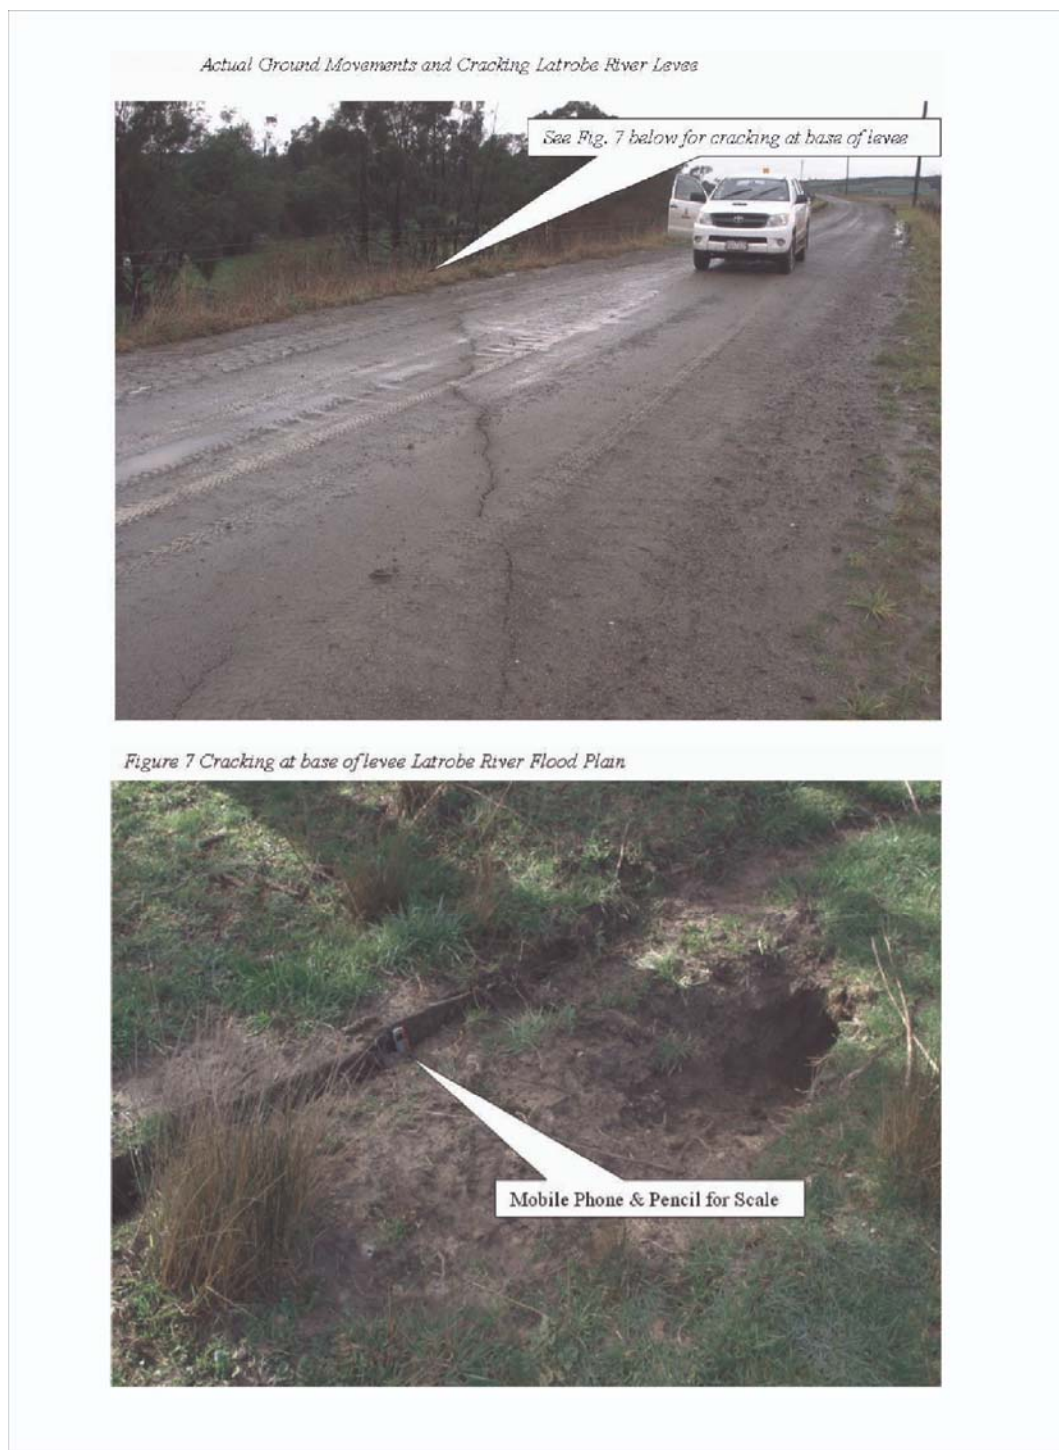
Figure 24: Cracking and subsidence on NE Batter in July 2007

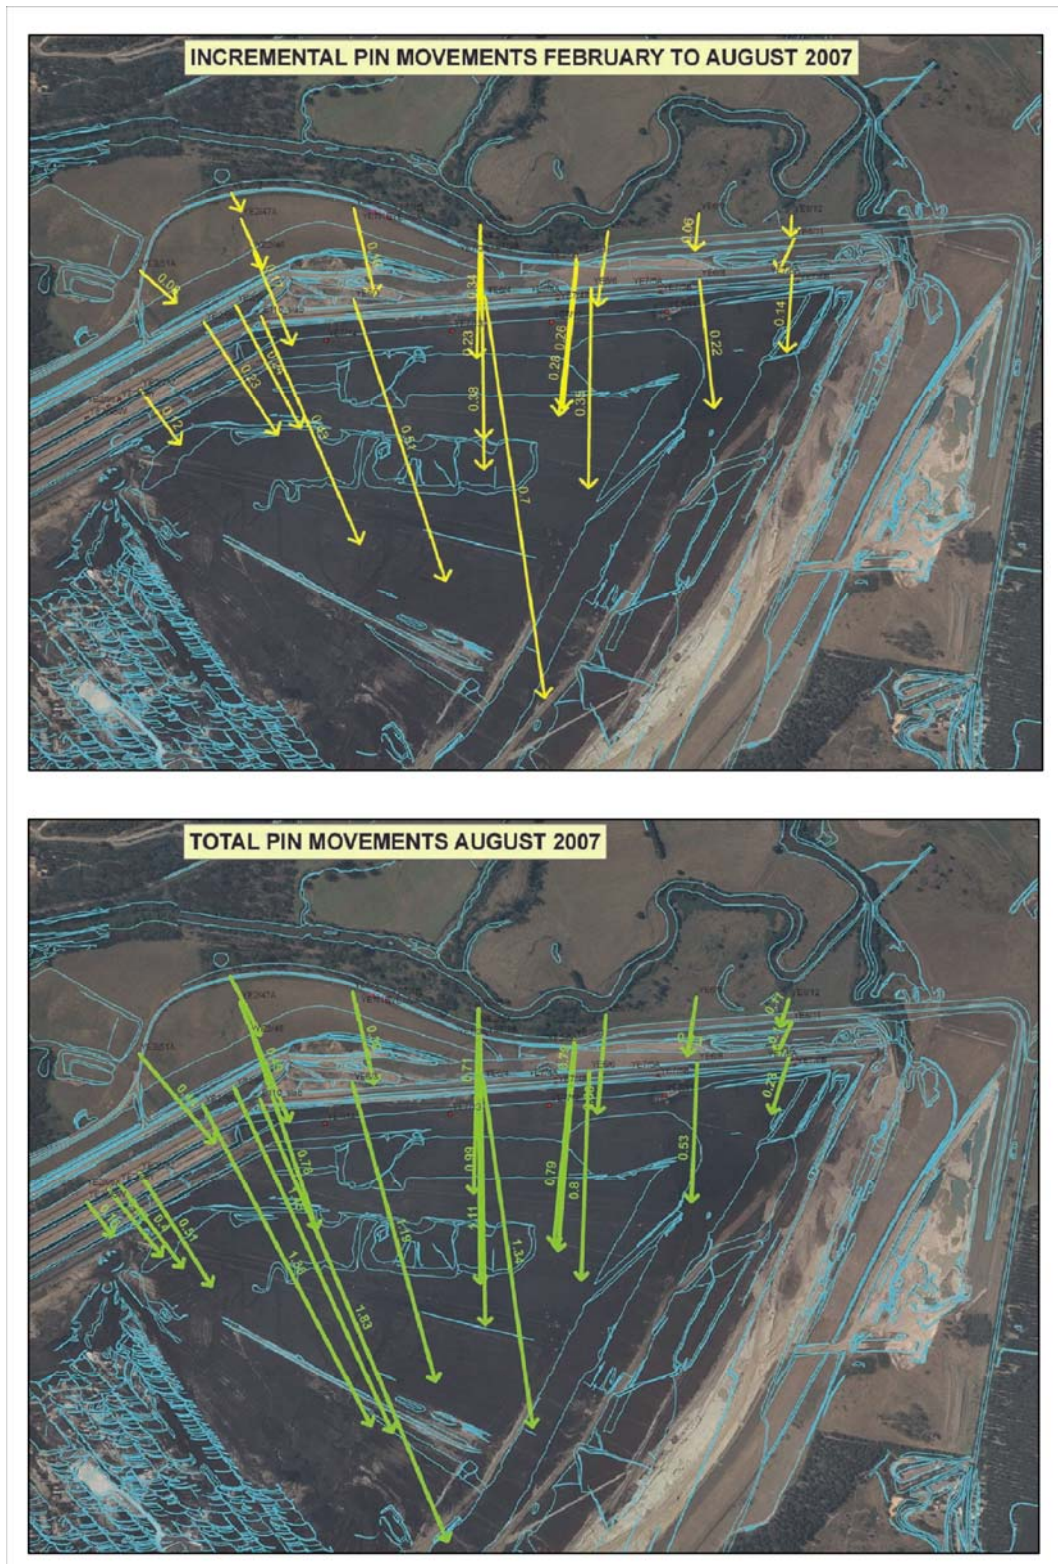
Figure 25: Vectors of movement for NE Batter in August 2007

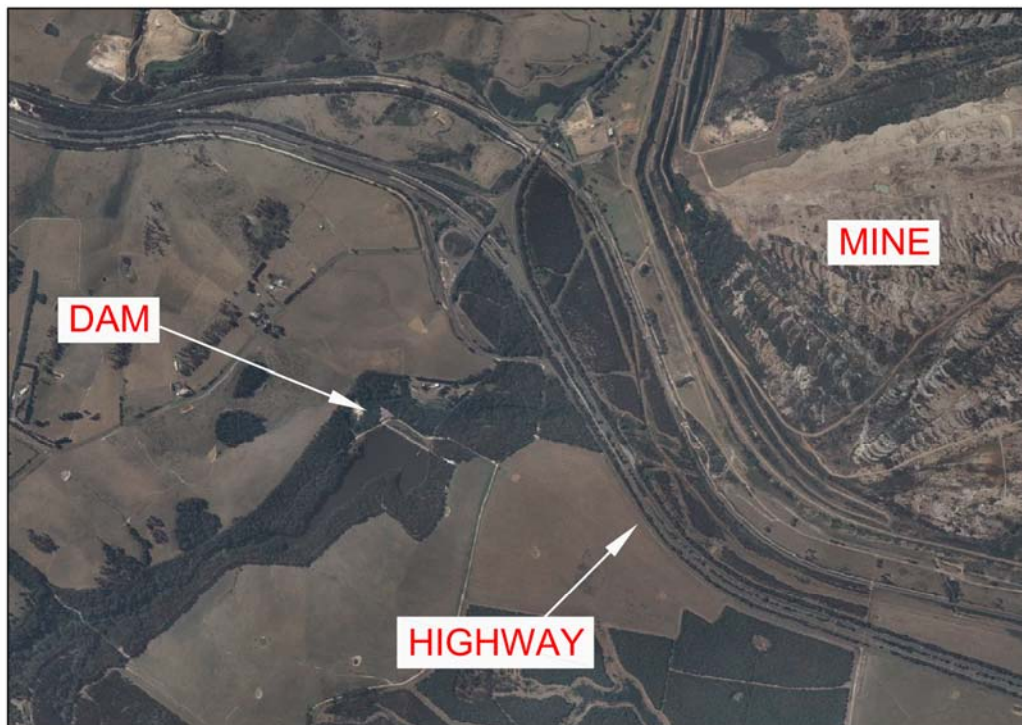
Figure 26: Wits Gully Dam
