**IN THE CORONERS COURT
HELD AT BURNIE**

**IN THE MATTER of the
CORONERS ACT 1995
-and-
IN THE MATTER OF INQUESTS
TOUCHING THE DEATHS OF
JARROD KEITH JONES,
MATTHEW DAVID LISTER and
SIDNEY THOMAS PEARCE**

Wednesday, 21 May 2008

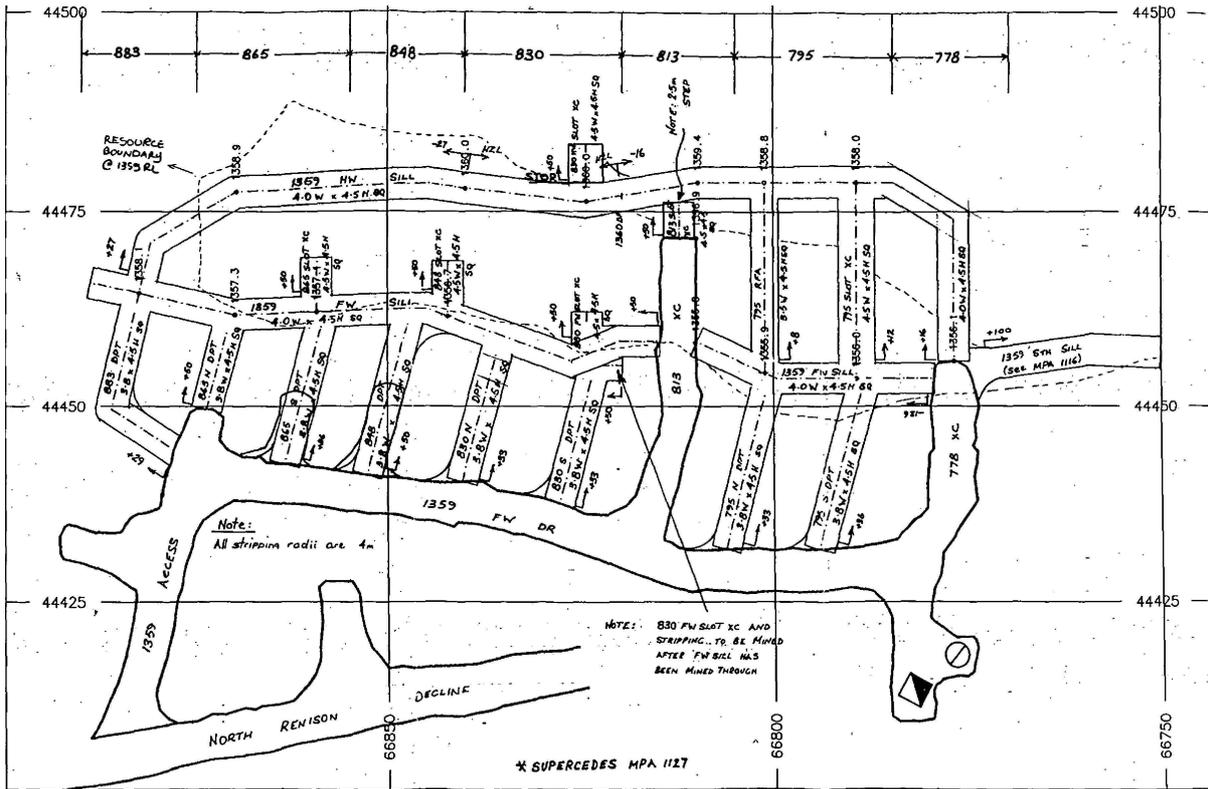
P71 - MDM 0274

* SUPERCEDES MPA 1127

RENISON LIMITED MINE PLANNING				APPROVED	
Date	23/10/00	C.M. Eng.	<i>[Signature]</i>	Sec. Co-ord.	<i>[Signature]</i>
Scale	1:500	Survey	<i>[Signature]</i>	Geology	<i>[Signature]</i>
Drawn	PHM	Vent Eng.	SVP R-11-00	Eng-Geol.	<i>[Signature]</i>
HUGH 1359 SILL				Drawing No.	
				MPA - 1138A

346. Mr Mayes gave evidence that when he found out the 778 cross cut was being extended he had specifically asked about whether the pillar would be undermined and the resulting stress changes caused by the development. He was told that "the ground was pretty reasonable as they advanced."¹⁴⁴ At the time Mr Mayes was in West Australia and he seemed to be satisfied with the explanations he was given.
